**SOUHEGAN RIVER WATERSHED
DAM NO. 28**

**NH 00429
NHWRB 147.26**

**PHASE I INSPECTION REPORT
NATIONAL DAM INSPECTION PROGRAM**

AUGUST 1979

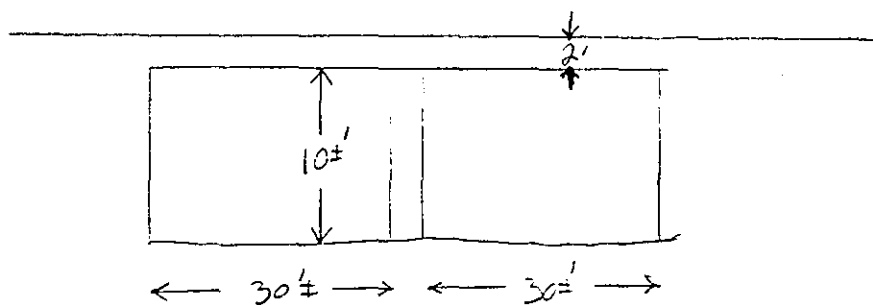
Railroad bridge 200' d/s of confluence

The estimated peak dam failure flow depth of 14' would probably damage the railroad bridge and roadbed.
